RAHWAY RIVER BASIN  
WEST BRANCH RAHWAY RIVER  
ESSEX COUNTY  
NEW JERSEY

# CAMPBELLS POND DAM

**NJ 00517**

**PHASE 1 INSPECTION REPORT  
NATIONAL DAM SAFETY PROGRAM**

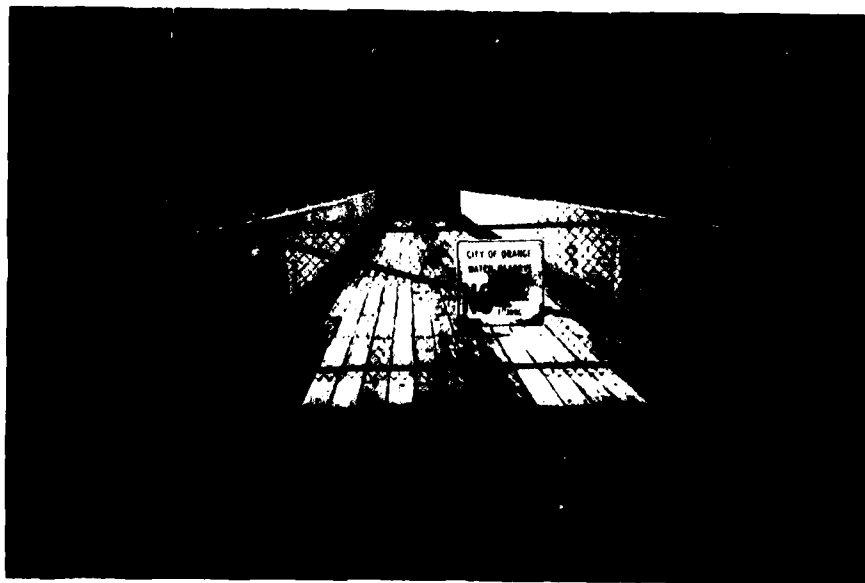
PHOTO 2  
TOP OF DAM - BRIDGE OVER SPILLWAY
